**INVESTIGATION INTO THE MAJOR CAUSES OF PAVEMENT  
FAILURE IN IFITE ROAD.**

**IN PARTIAL FUFILLMENT OF THE REQUIREMENTS FOR THE  
AWARD OF BACHELOR OF ENGINEERING (B.ENG) DEGREE IN  
CIVIL ENGINEERING**

The study was undertaken to investigate the major causes of pavement failure in Ifite Road. Four samples of soils within the failed section of the pavement designated as A, B, C and D were subjected to geotechnical testing. The samples were collected along Miracle Junction, Yahoo Junction, Commissioner Quarters and First Market respectively. The geotechnical test that was performed on the samples are sieve analysis test, compaction and CBR test. Results obtained from sieve analysis test classified the samples as A-2 for samples A, C, D and A-4 for B, according to AASHTO Soil Classification System. The maximum dry unit weight of the samples were  $16.90\text{kN/m}^3$ ,  $18.87\text{kN/m}^3$ ,  $17.30\text{kN/m}^3$  and  $15.84\text{kN/m}^3$ , the optimum moisture content of the samples were 12.08%, 12.53%, 11.17% and 14.21% respectively. The soaked CBR of the samples are for samples A, B, C, D respectively. The samples failed to meet the requirements given by Federal Ministry of W

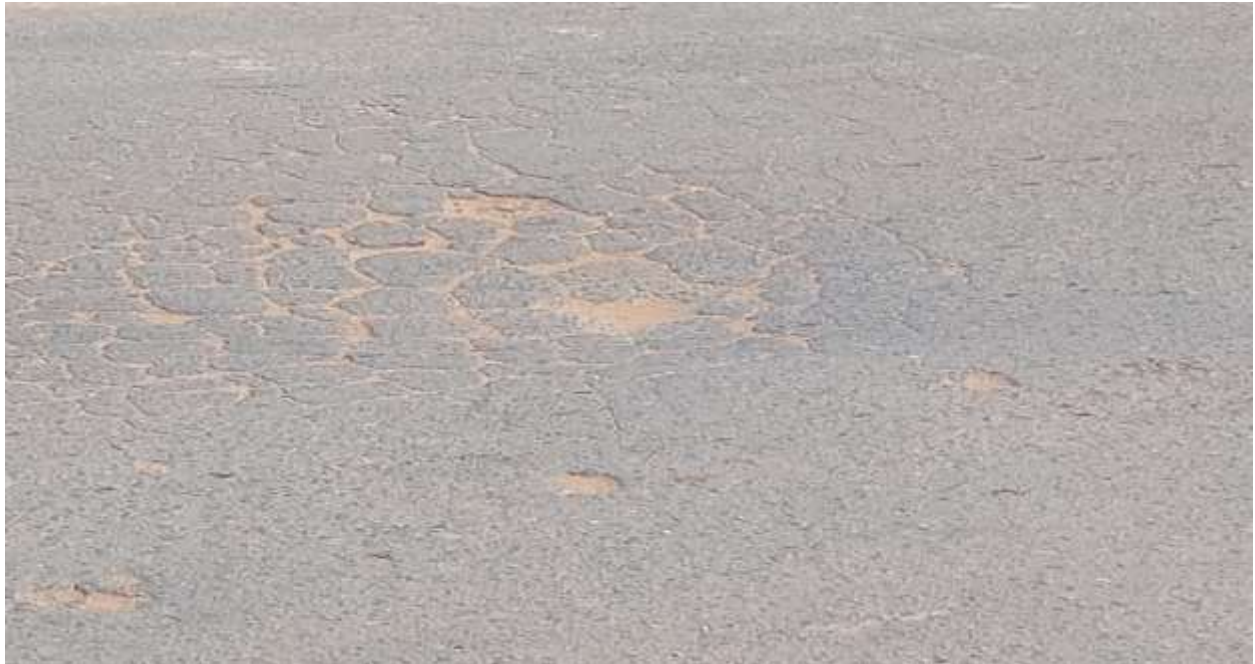
Alligator cracking are series of interconnected cracks caused by fatigue failure of the hot mix asphalt surface under repeated traffic loading (Mehedi and Mohd,2020). As the number and magnitude of loads increases, longitudinal cracks begin to develop and after repeated loading, these longitudinal cracks connect forming many sided-angled pieces that develop into a pattern which takes the shape of an alligator or crocodile (Mehedi and Mohd,2020). This cracking is likely due to infiltration of water into the pavement.

**Plate 2.1 : Alligator Mapping Along Commissioner Quarters Ifite Road.**

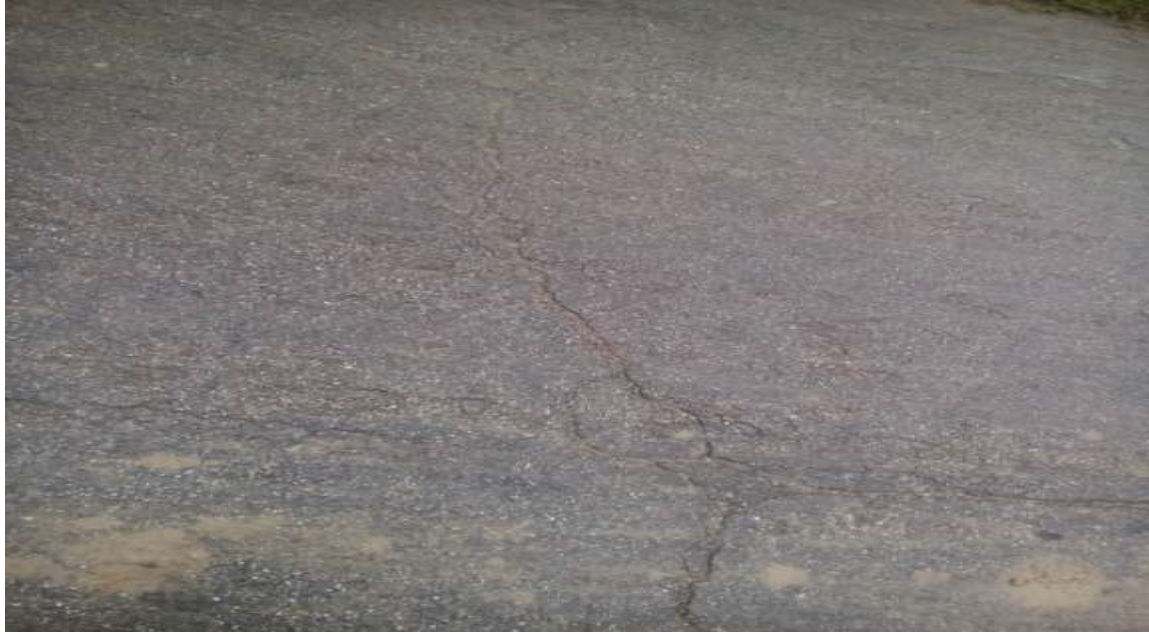
These are cracks perpendicular to the pavement centerline Mehedi and Mohd (2020). This cracks are caused by shrinkage of hot mix asphalt surface due to low temperature or asphalt binder hardening, it is also referred to as thermal cracking.

**Plate 2.2: Photograph of Transverse Cracking (source:Field)**

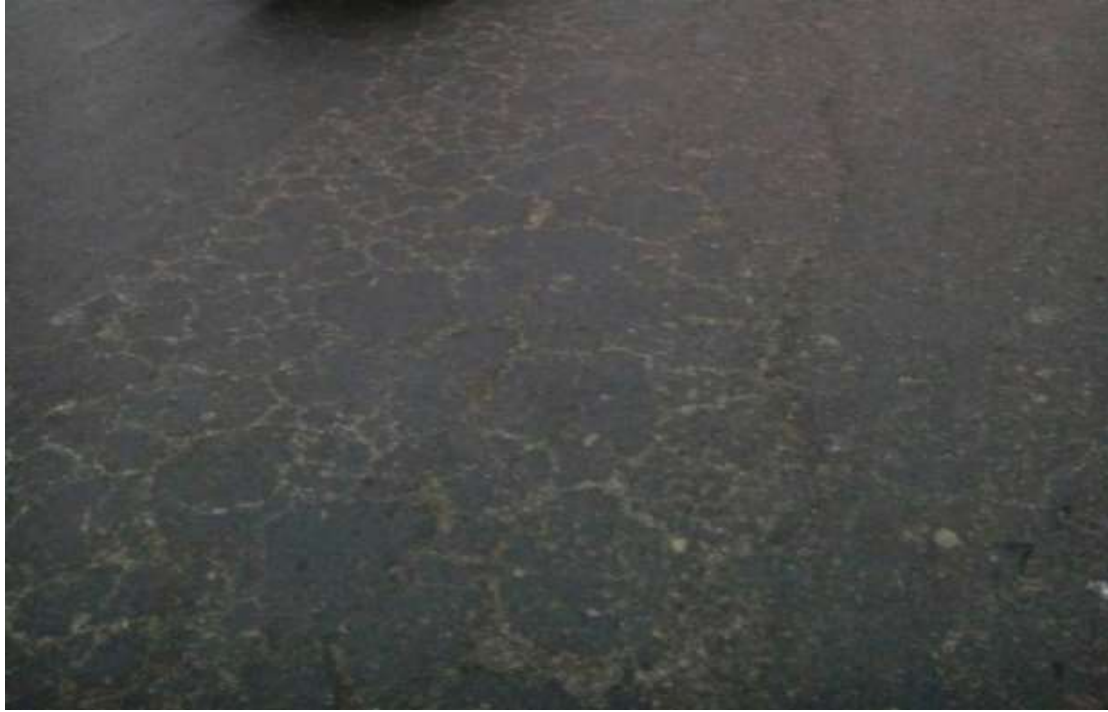
This cracking is mainly caused by shrinkage of the asphalt concrete and daily temperature cycling and it is not load associated (Mehedi and Mohd ,2020). The occurrence of block cracking usually indicates that the asphalt has hardened significantly. This cracking usually occurs over a large portion of pavement area.

**Plate 2.3: Photograph of Block Cracking (Mehedi and Mohd,2020).**

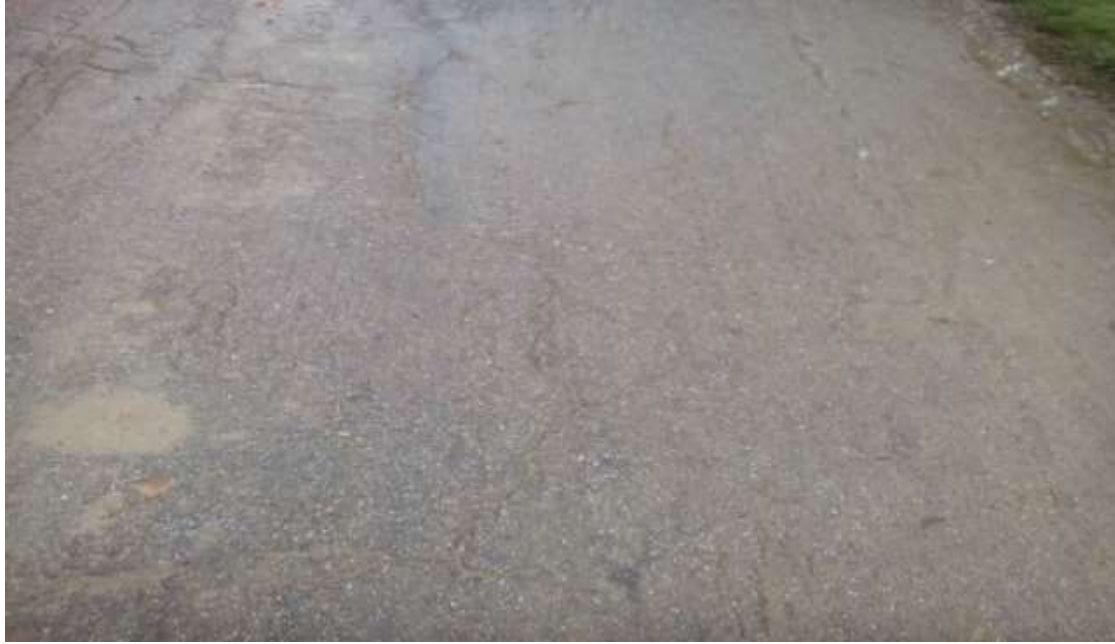
These are cracking that occurs in the surface of road and runs lengthwise along the pavement. It can consist of a single crack or as a series of parallel cracks. This crack occurs as a result of asphalt hardening, diurnal temperature fluctuations and reflection of a crack or joint in the road pavement (Mehedi and Mohd,2020).

**Plate 2.4: Photograph of Longitudinal Cracking (Mehedi and Mohd,2020).**

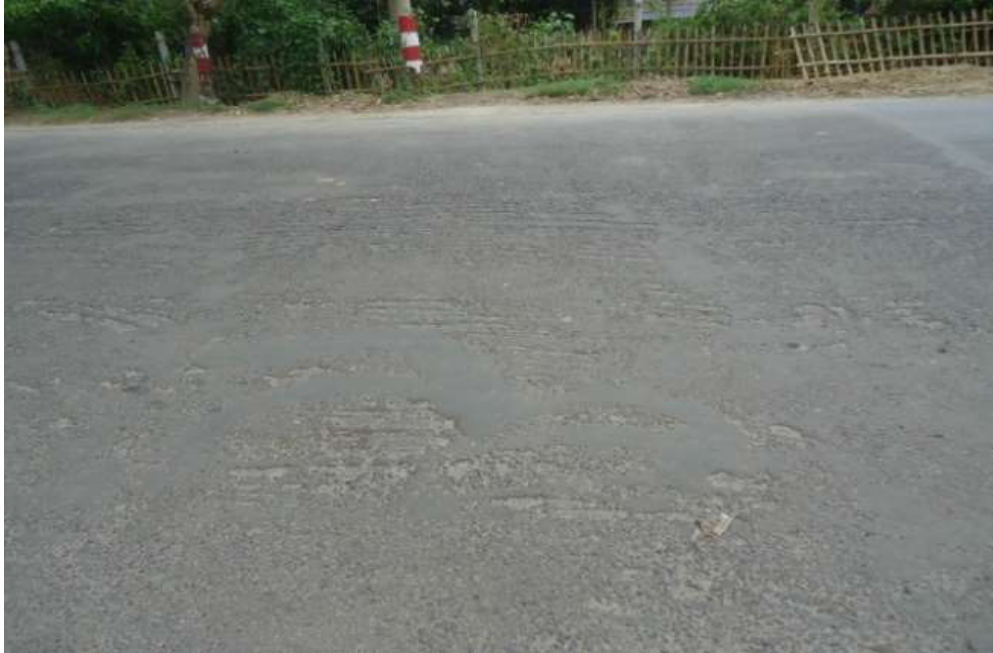
Due to poor bonding between pavement layers, slippage cracking appears as crescent-shaped (half-moon) or wave-like cracking (Mehedi and Mohd,2020). This type of pavement can be caused by poor bonding of material with an underlying layer or a low strength surface mix and may be exacerbated by continual traffic braking or wheel turning (Mehedi and Mohd,2020). This cracking create rough riding surface, voids and bulges and will begin incurring heavier and heavier impact forces from traffic, which will increase the damage. This will cause potentially larger damage subsequently; especially as water channeling and penetration damage the pavement base and advance the deterioration.

**Plate 2.5: Photograph of Slippage Cracking (Mehedi and Mohd,2020).**

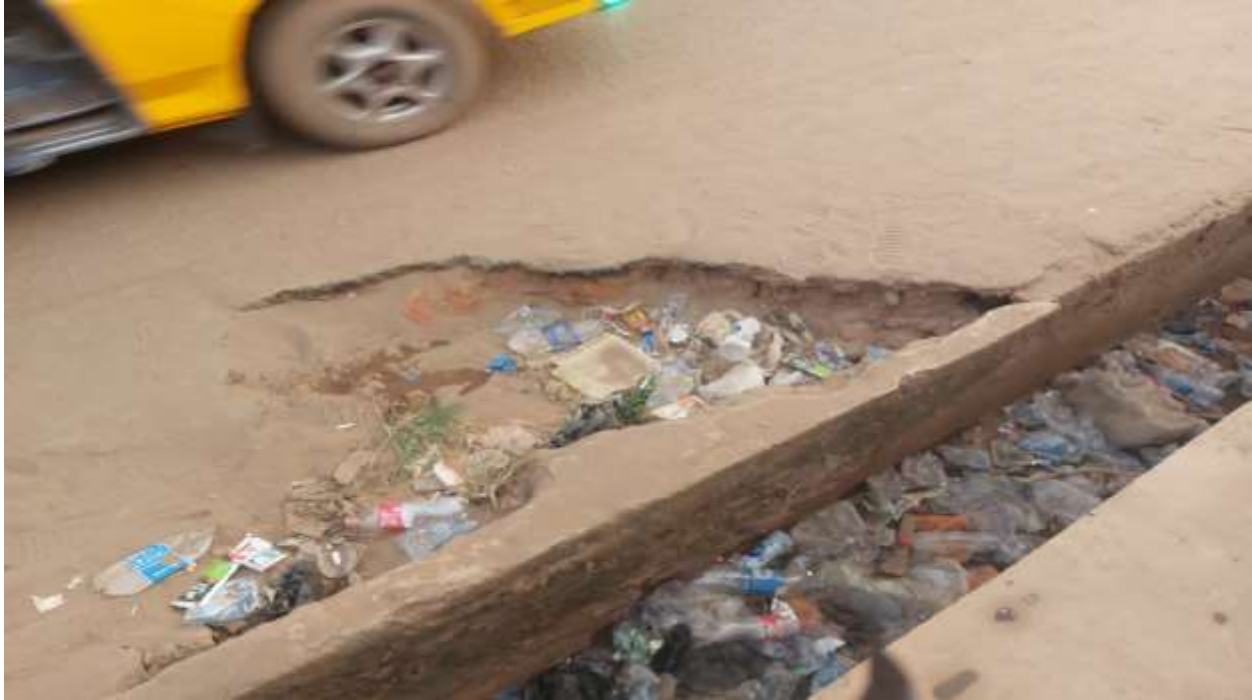
A pothole is a defect created on the road surface as a result of the primary failure in the asphalt pavement used in road making, which leads to the structural failure of the road surface (Mehedi and Mohd,2020). The asphalt pavement failure occurs due to the presence of water in the underlying soil structure and the presence of traffic passing over the affected area on the road (Mehedi and Mohd,2020). The water in the underlying soil structure can come from floods, underground erosions or cracks from the road surface.

**Plate 2.7: Photograph of Pothole along miracle junction ifite road (source: Field).**

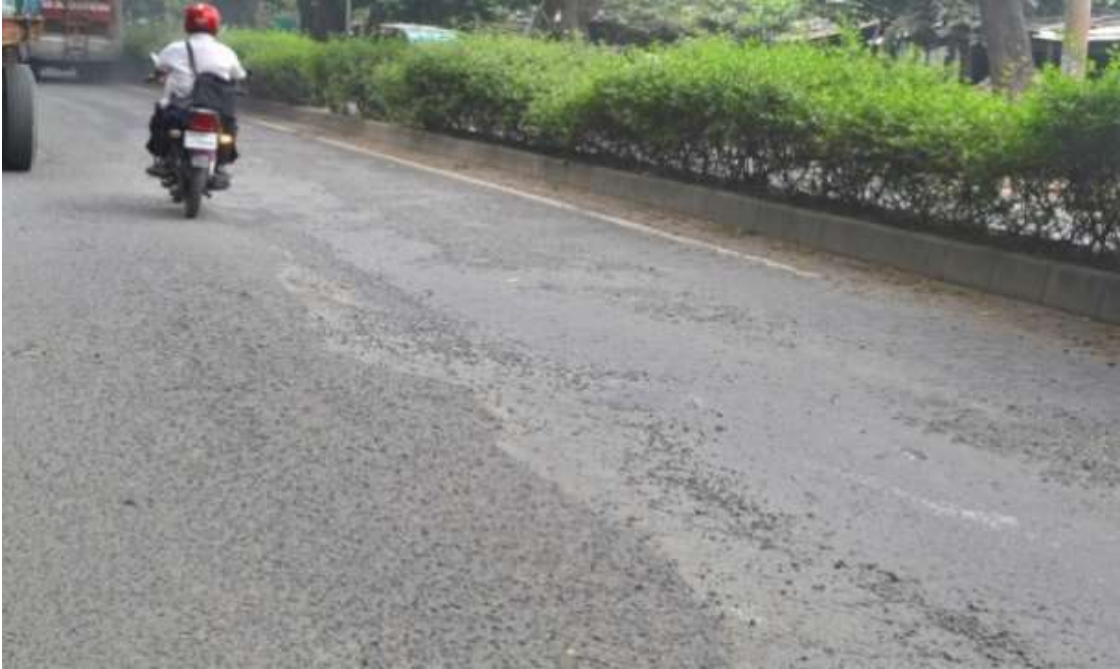
Raveling refers to the progressive disintegration of hot mix asphalt layer from the surface downward as a result of the dislodgement of aggregate particles (Mehedi and Mohd,2020). It is caused by loss of bond between aggregate particles and the asphalt binder as a result of dust coating on the aggregate particle particles that forces the asphalt binder to bond with the dust rather than the aggregate, it is also caused by aggregate separation where the fine particle are missing from the aggregate matrix, then the asphalt binder is only able to bind the remaining coarse particles at their relatively few contact points. Inadequate compaction during construction also causes raveling as high density are required to develop sufficient cohesion within the hot mix asphalt.

**Plate 2.8: Photograph of Raveling (Mehedi and Mohd,2020).**

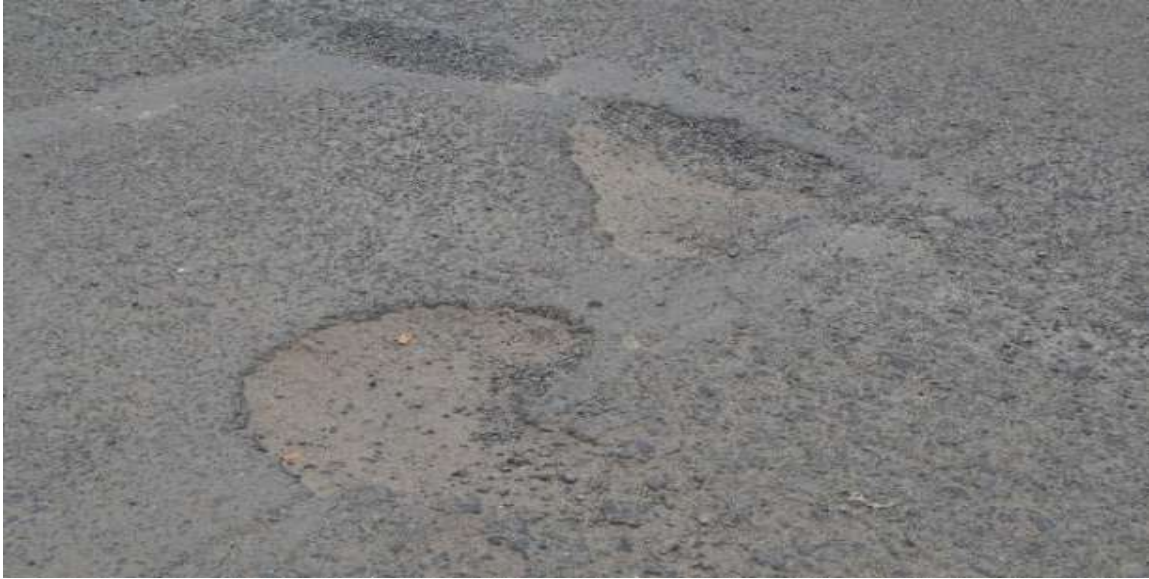
Depressions are localized pavement surface with slightly lower elevations than the surrounding pavement (Mehedi and Mohd,2020). They are very noticeable after infiltration of water as a result of rainfall; they are caused by frost heave, uneven sub-base or sub-grade settlement resulting from inadequate compaction during construction (Mehedi and Mohd,2020). Depression can be repaired by removing the affected pavement then digging out and replacing the area of poor sub-grade patch over the repaired sub-grade.

**Plate 2.9: Photograph of Depression 9(Mehedi and Mohd,2020).**

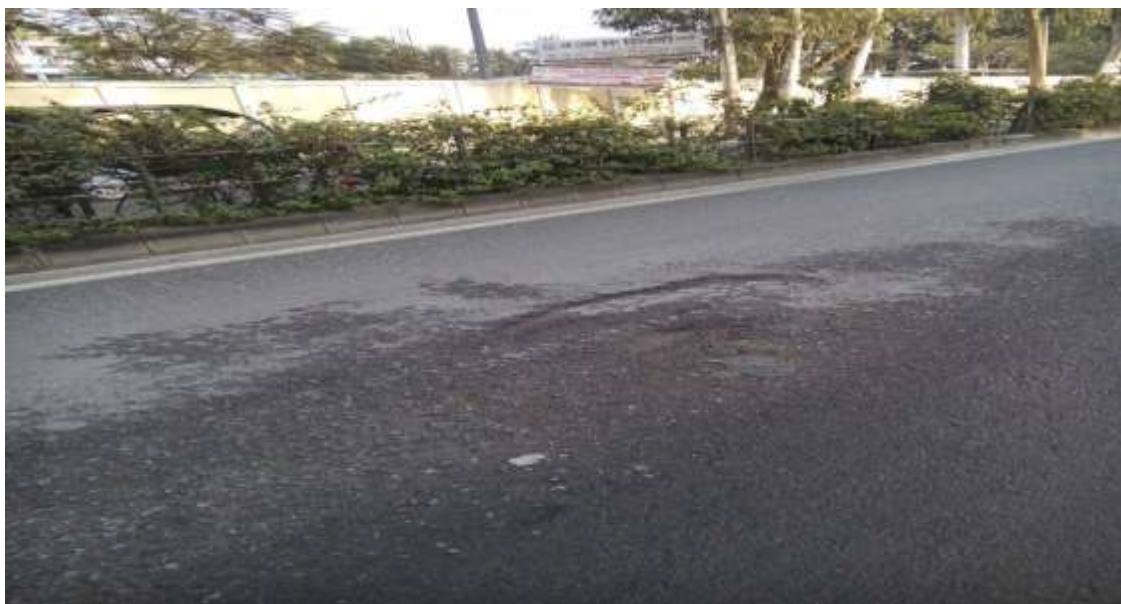
Water bleeding of pavement occurs when water seeps out of joints or cracks or through an excessively porous hot mix asphalt layer, it is caused by inadequate compaction during construction or poor mix design, high water table and poor drainage, low air void content (Mehedi and Mohd, 2020).

**Plate 2.10: Photograph of Water Bleeding (Mehedi and Mohd ,2020).**

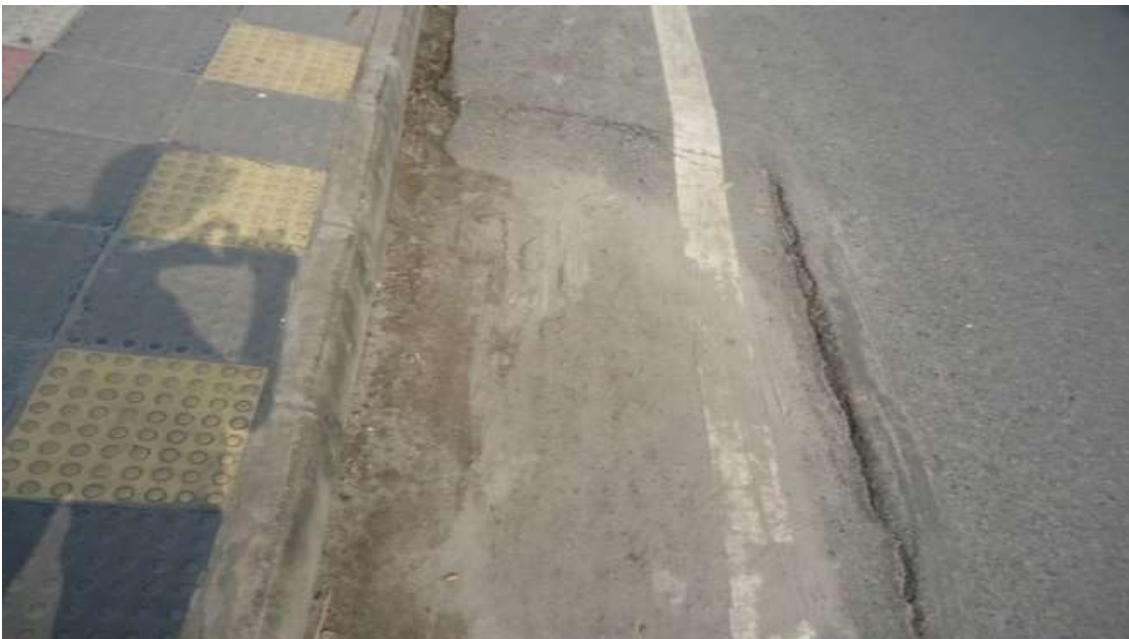
A rut is a permanent longitudinal surface depression that occurs in the wheel paths of a flexible pavement due to the passage of traffic (Mehedi and Mohd,2020). Ruts accumulate incrementally with traffic volume; rut depth at any location is measured as the vertical distance between the top of the heave and the bottom of the depression, rut are caused primarily by asphalt layer problems, structural layer problems and weak sub-grade problems (Mehedi and Mohd,2020).

**Plate 2.11: Photograph of Rutting (Mehedi and Mohd,2020).**

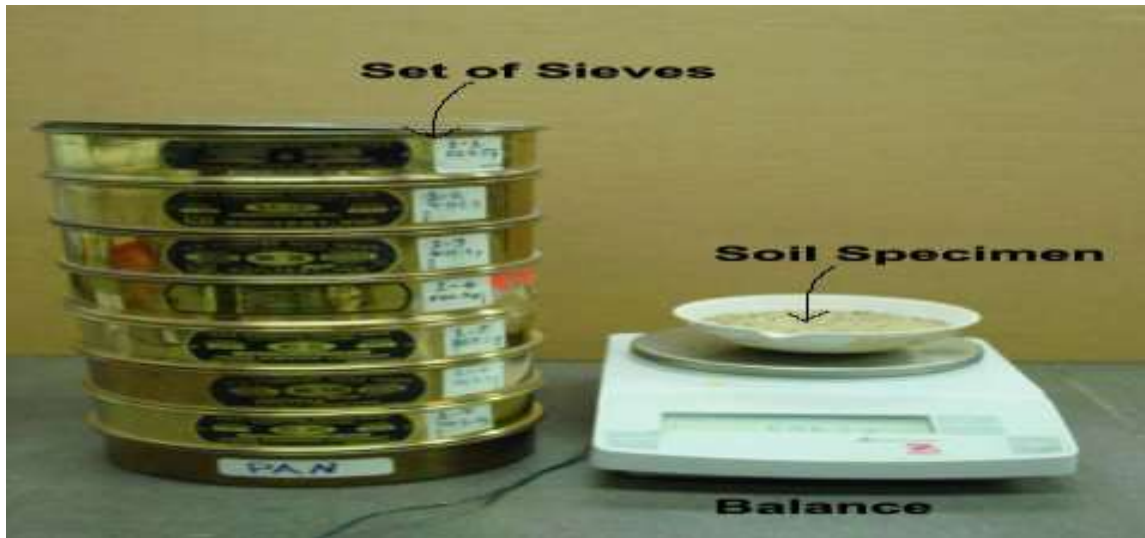
**Plate 3.2: Apparatus for Particle Size Distribution Test Source: (Braja,2006).**

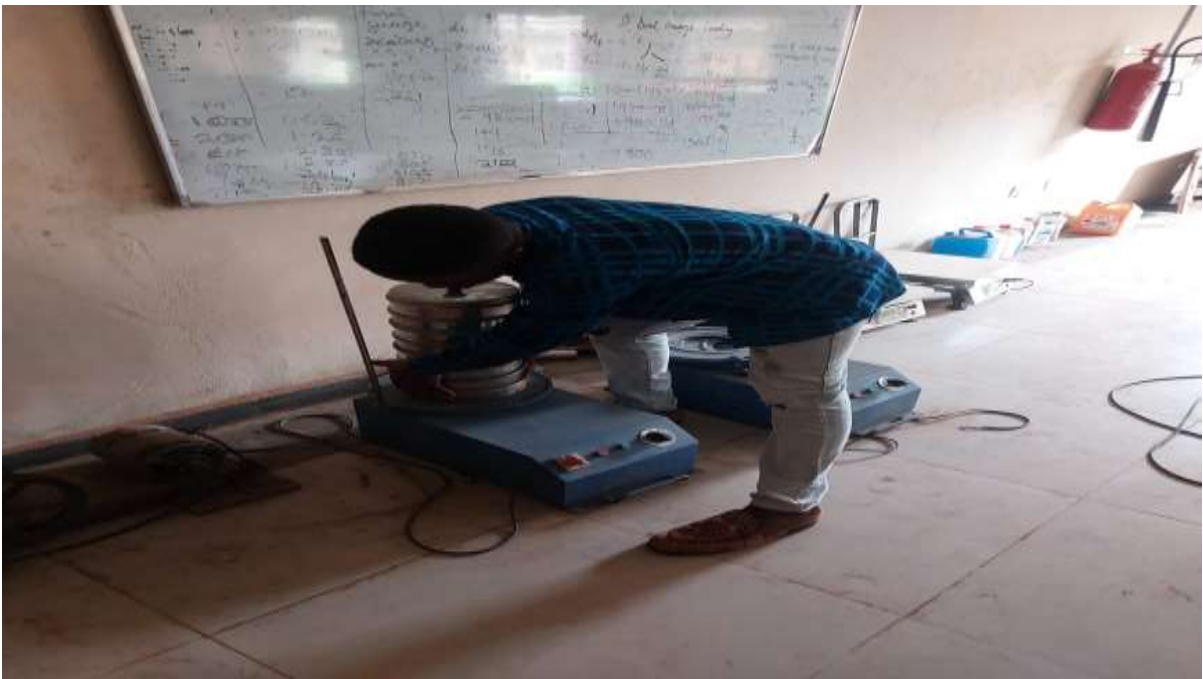
**Plate 3.3: Arrangement of Stack of Sieves on a Mechanical Sieve Shaker**

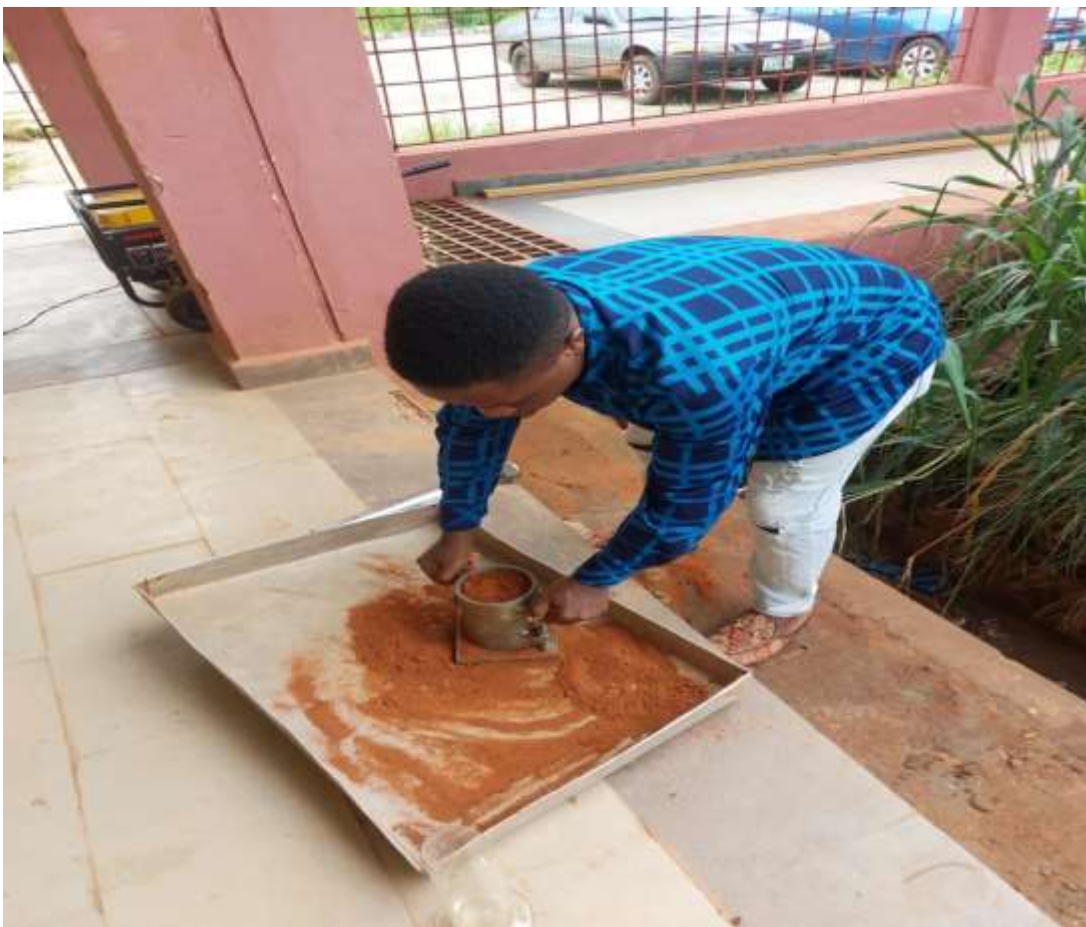
**Plate 3.5: Arrangement of Mould Assembly**

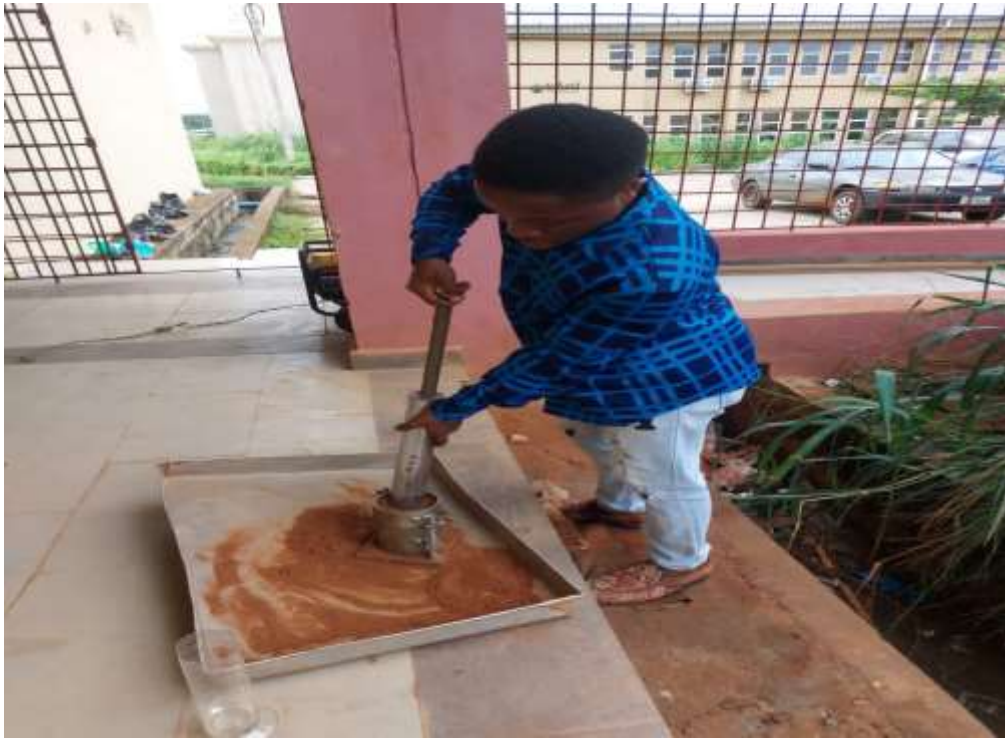
**Plate 3.6: Manual Compaction of Soil Sample**

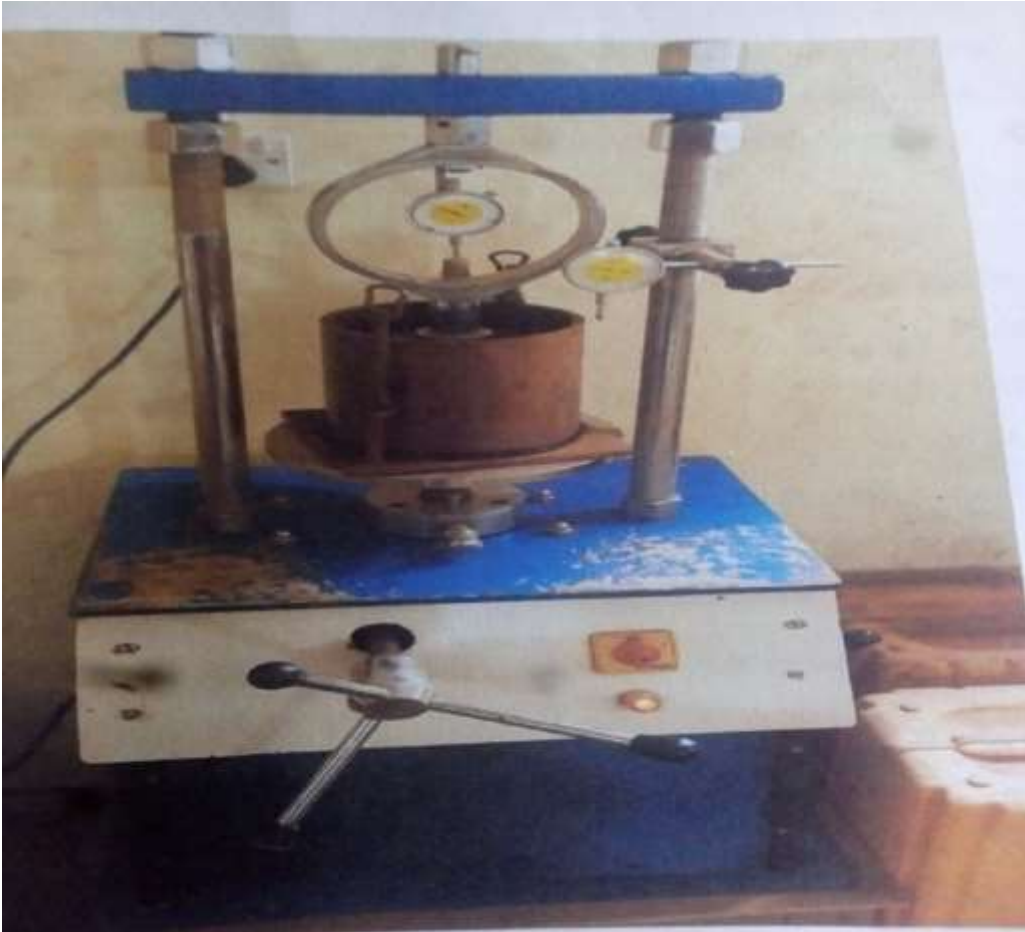
**Plate 3.7: California Bearing Ratio (CBR) Test Machine.**

1. The apparatus used for the test are outlined below:
2. A cylindrical corrosion resistant mould 152mm×127mm having a diameter of 150-152mm with a detachable base plate and a removable extension collar.
3. A compressive device for static compaction of applying a force of at least 300KN
4. Metal plugs 150mm  $\pm$  0,5mm and 50mm thick.
5. Metal rammer 2.5kg or 4.5kg.
6. Dial gauge of 0.01g sensitivity.
7. Soaking tank.
8. A steel rod of about 16mm diameter and 600mm long and a straight edge of 300mm steel stripe and 3mm thick with one beveled edge.
9. Weighing balance of 25kg accuracy and a spatula.
10. Filter paper
11. Apparatus for moisture content determination.
12. Masking tape used for identification of moisture content tins.

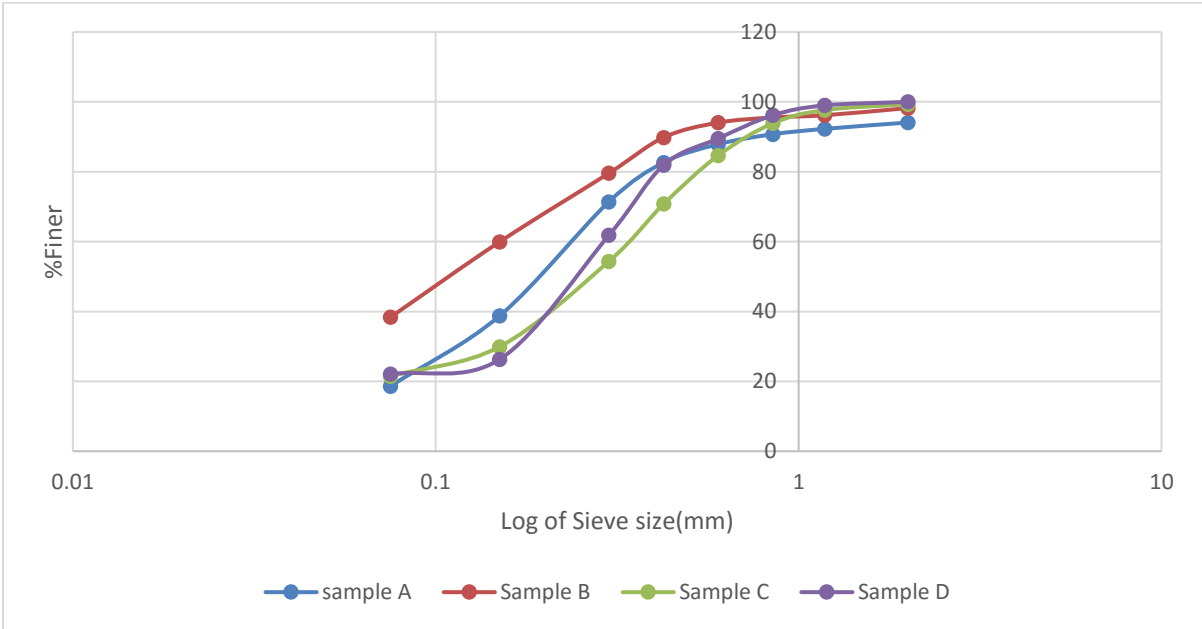
**Fig 4.2.3: Particle Size Distribution Graph for Samples**

Figure 4.2.3 is the semi logarithmic plot of the particle size distribution of the soil samples. From the graph of Figure 4.2.3, the percentage passing Sieve No 200 (0.075mm) are 18.61%, 38.86%, 21.46%, and 22.07% respectively. According to AASHTO Classification System, the samples A, C and D are classified as A-2 while sample B is classified as A-4. According to the Federal Ministry of work Standard Specification for roads and bridges (1997), since more than 35% of the samples passes through sieve No 200 (0.075mm), sample B does not satisfy the requirement of a good sub-grade material for road construction. According to AASHTO classification of soil samples for highway, A-1 and A-2 soils are excellent and good soils for highway, while A-3 to A-7 soils are fair to poor soils. The result obtained classified the samples A, C and D as good soils due to the fact that less than 35% passes through sieve No 200 while sample B was classified as fair soil due to the substantial amount of finer materials passes through sieve No 200 (0.075mm). Clay is a problematic soil due to its porosity, low permeability and low shear strength. The presence of clay in the sample B tested could be responsible for instability of the pavement structure.

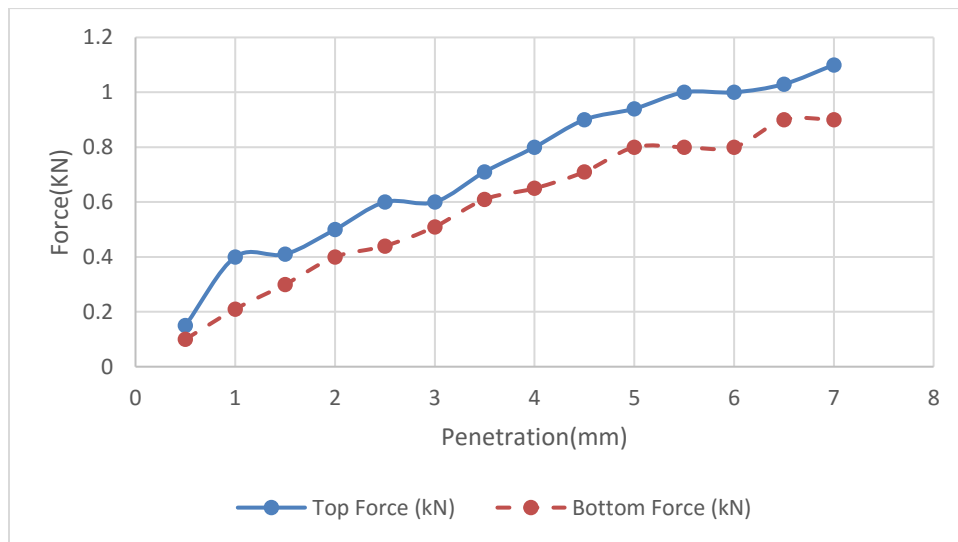
**Figure 4.3: Chart Showing the Soaked CBR of the Sample A**
